Chena River Lakes Project  
Fairbanks, Alaska

*Overview of Tanana River monitoring and  
research studies near Fairbanks, Alaska*

OVERVIEW OF TANANA RIVER MONITORING AND  
RESEARCH STUDIES NEAR FAIRBANKS, ALASKA  
(with Appendices)

Prepared by  
U.S. Army Cold Regions Research and Engineering Laboratory  
Hanover, New Hampshire

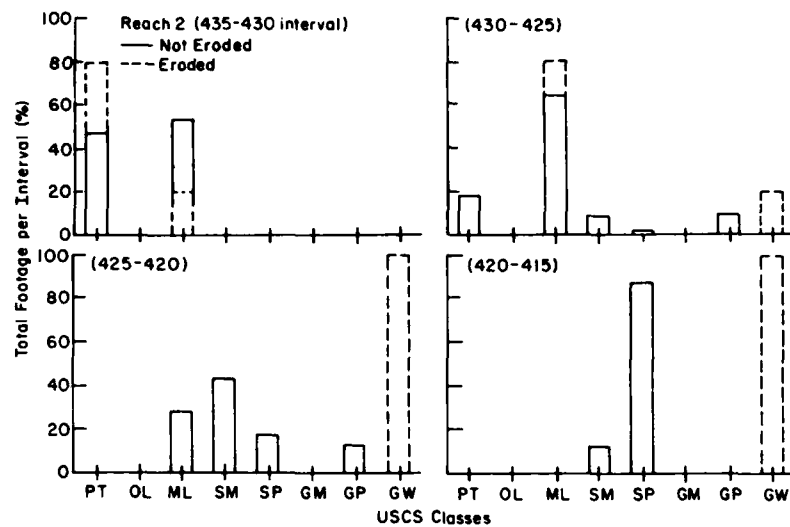
Figure 15. Sediments in eroded and uneroded wells, reach 2.

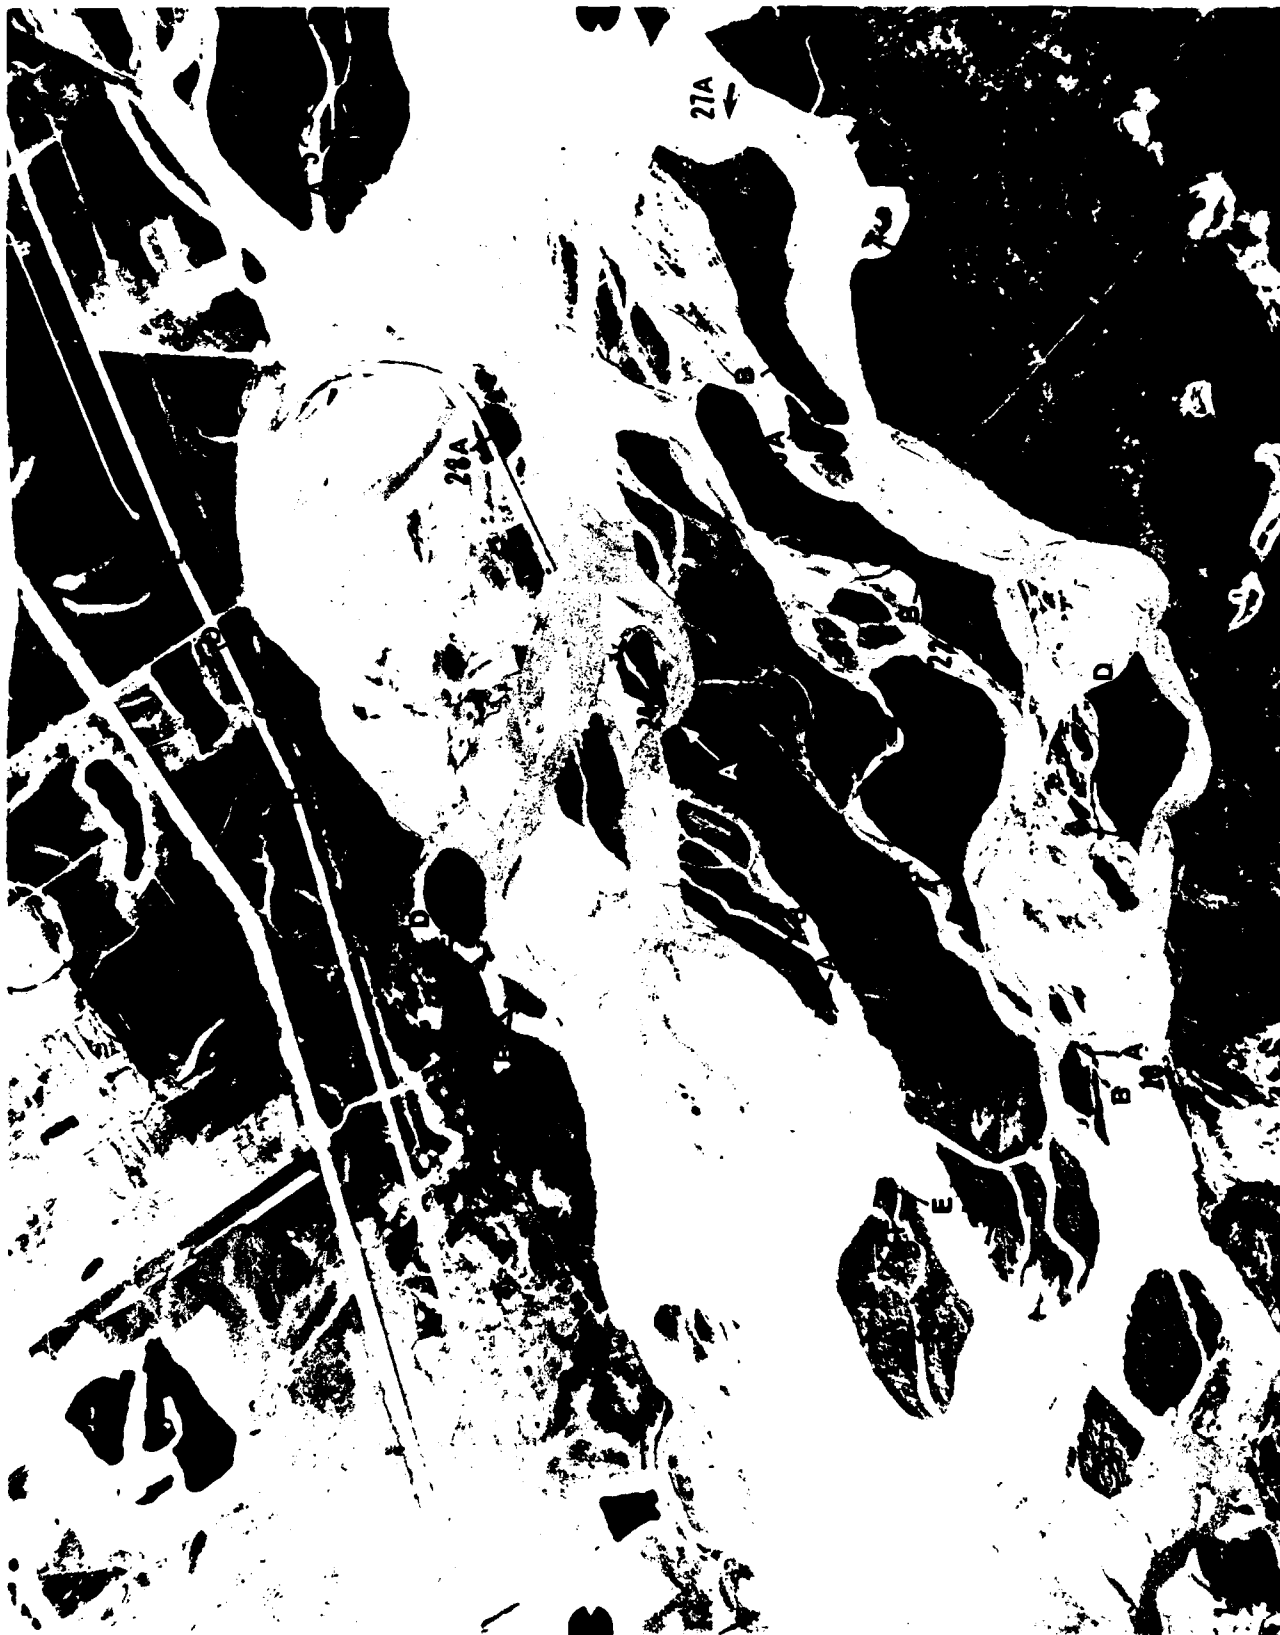
Figure 2. Measuring line locations near the North Pole groin (mapping base 17-10, Fig. 1).

Groin construction began over the winter of 1974-1975 and was complete prior to May 1975 (Figs. 7 and 8). The groin completely cut off the large north channel meander and diverted the river away from the north bank for a distance of about 1.3 miles to a site downstream of site 3 (Fig. 2). The groin reduced the active channel which was 5900 ft wide by 3300 ft. The width of the post-construction channel was 2600 ft, 46% smaller than the pre-construction width.

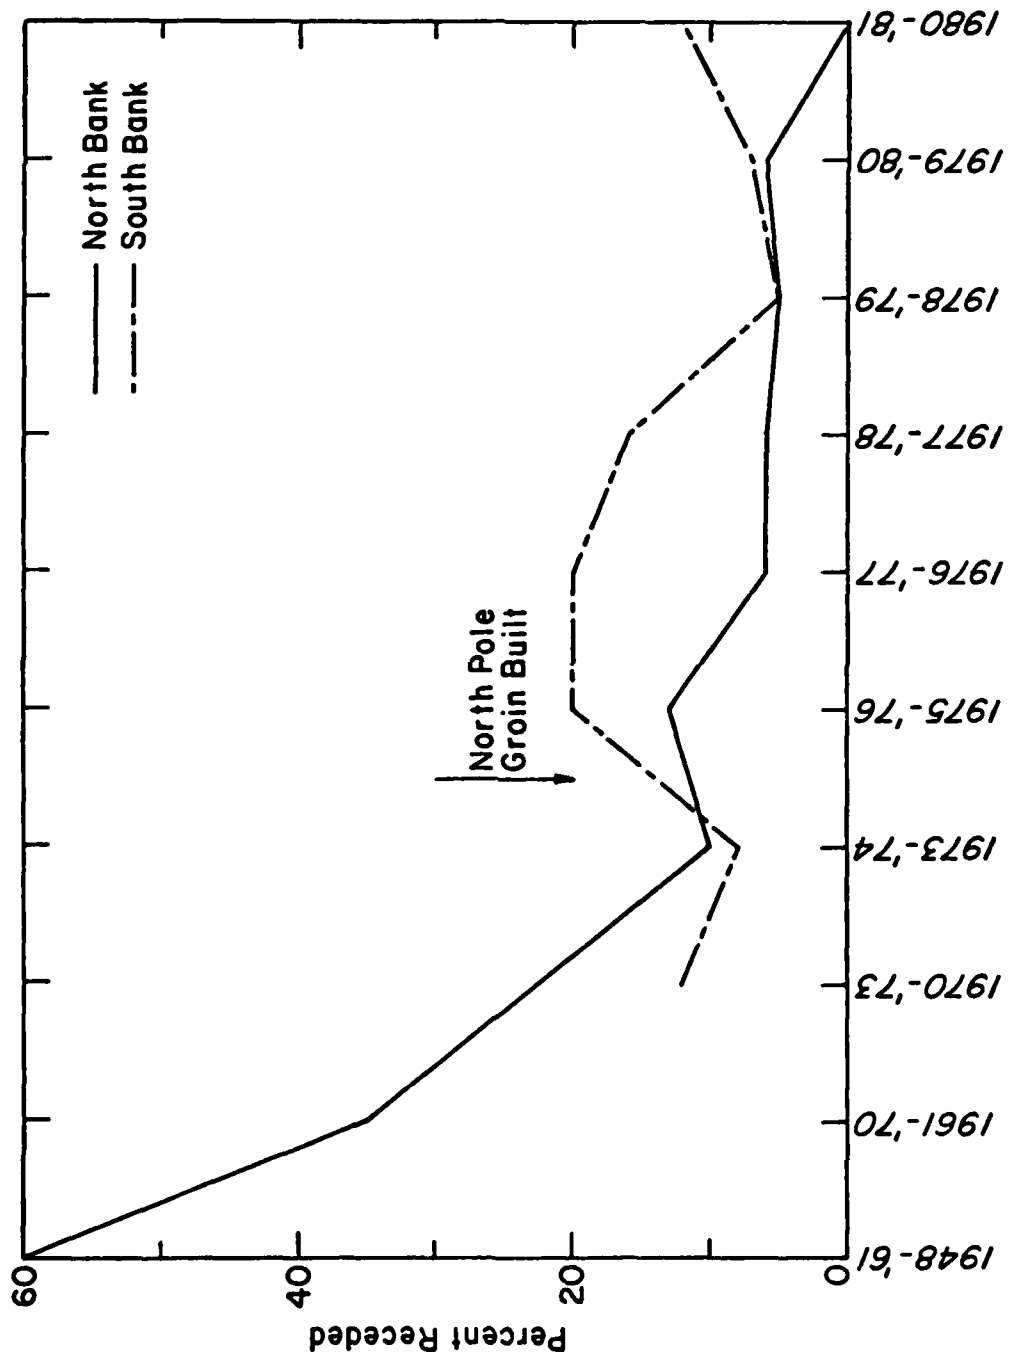
Figure 3. Percentages of north and south banks in the North Pole groin area receding per interval.

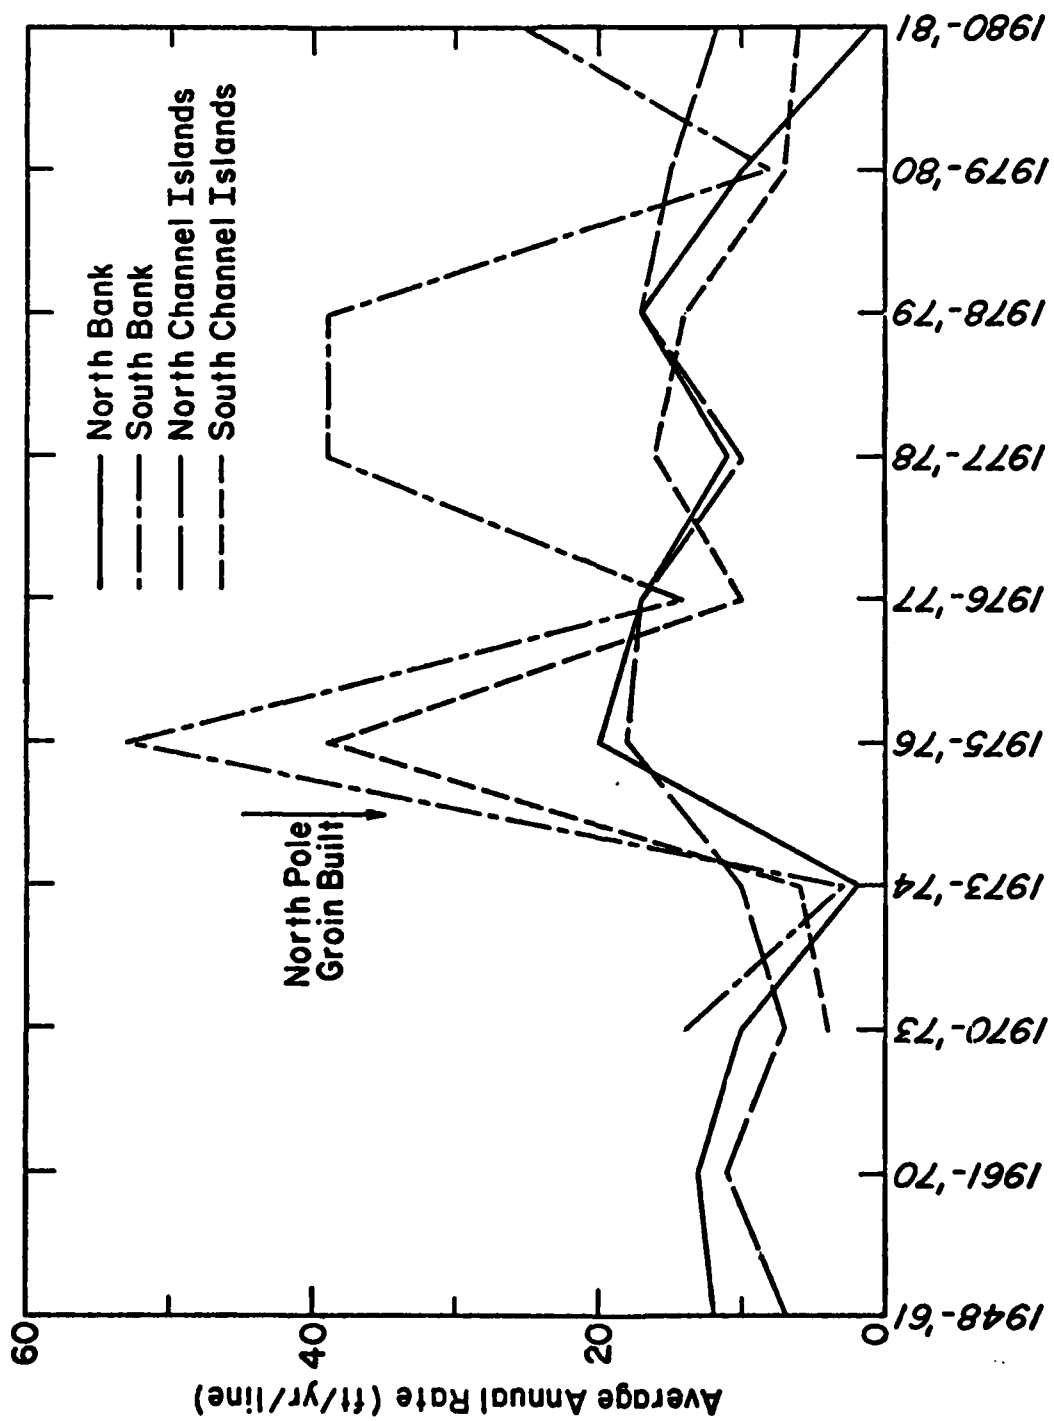
Figure 4. Average linear recession rate per measuring line in the North Pole groin area.

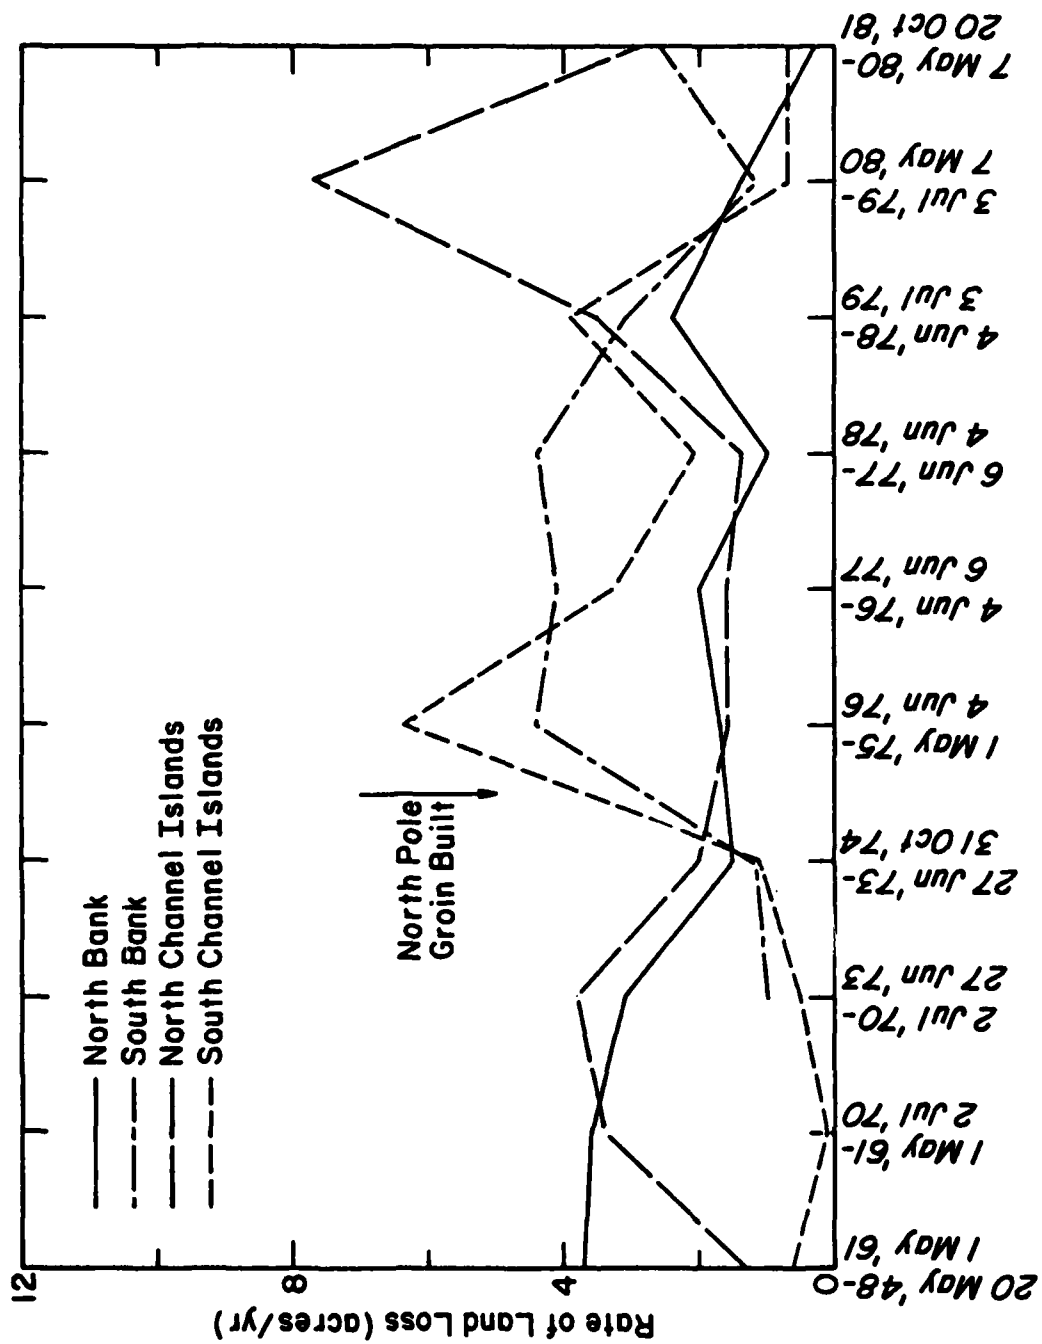
Figure 6. Rate of land lost in the North Pole groin area.

Most of the land, 48.3 acres, eroded during this interval was along the north bank (Table 3; Fig. 5). The north channel islands lost 16.6 acres and the south channel islands lost 7.6 acres. The rate of land lost during this interval were 3.7, 1.3 and .6 acres/yr for the north bank, north channel islands and the south channel islands, respectively (Table 3; Fig. 6).

The amount of land lost along the northern part of the channel decreased from the previous interval (Fig. 5) and the rate of loss along the north channel islands was higher than along the north bank (Fig. 6). The amount and rate of land lost along the south channel islands increased from the previous interval.

The amounts of land lost increased along the north and south channel islands and the south bank, but decreased slightly along the north bank (Table 3). The rate of loss along the north bank decreased while the rate increased along the south bank (Fig. 6).

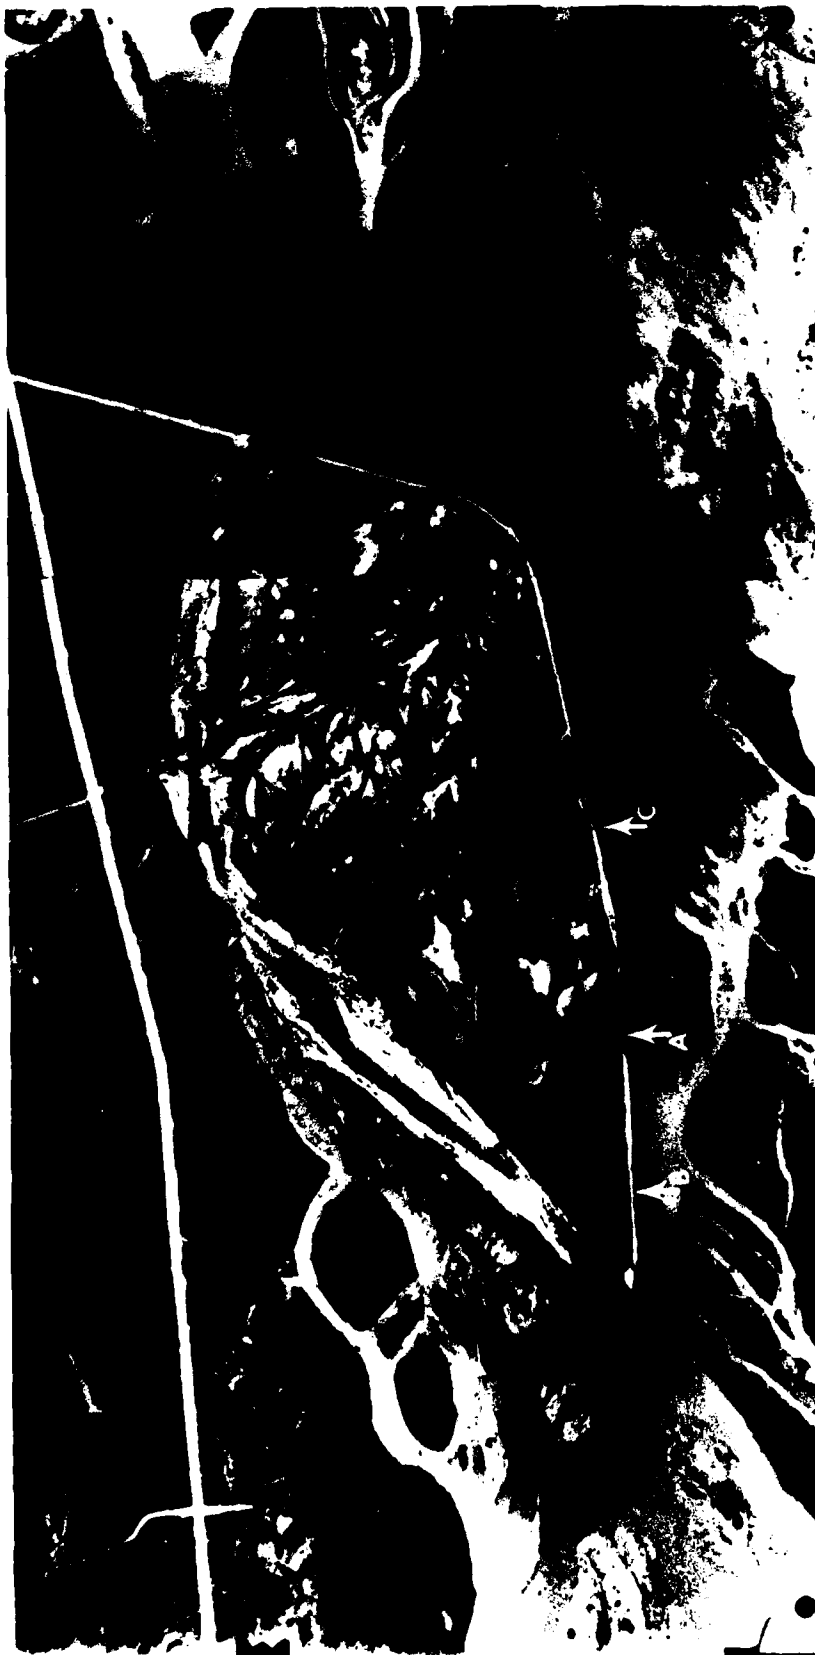
Figure 8. North Pole groin, 14 May 1975

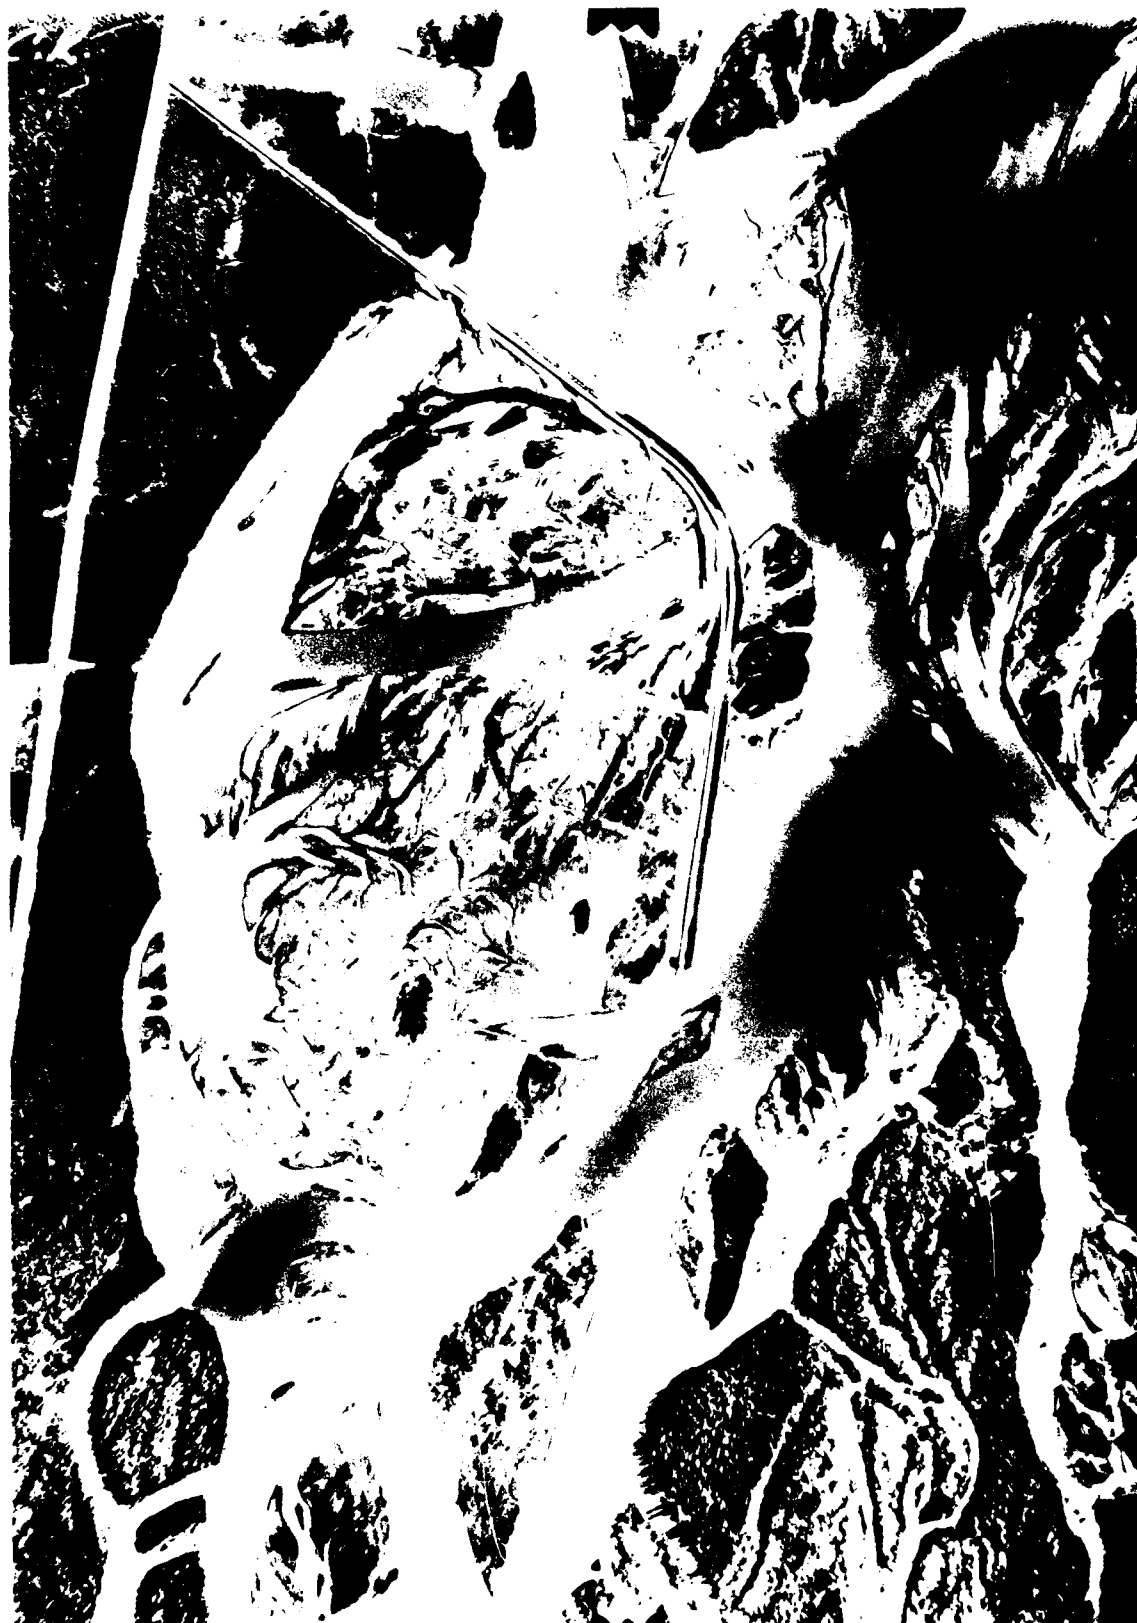
Figure 9. North Pole groin area, 26 September 1975.

1975 (Fig. 9) the dike downstream of "C" was nearly completely eroded away. Only a remnant between "A" and "B" remained. The river was again attacking the banks at sites 2 and 3 (Fig. 9).

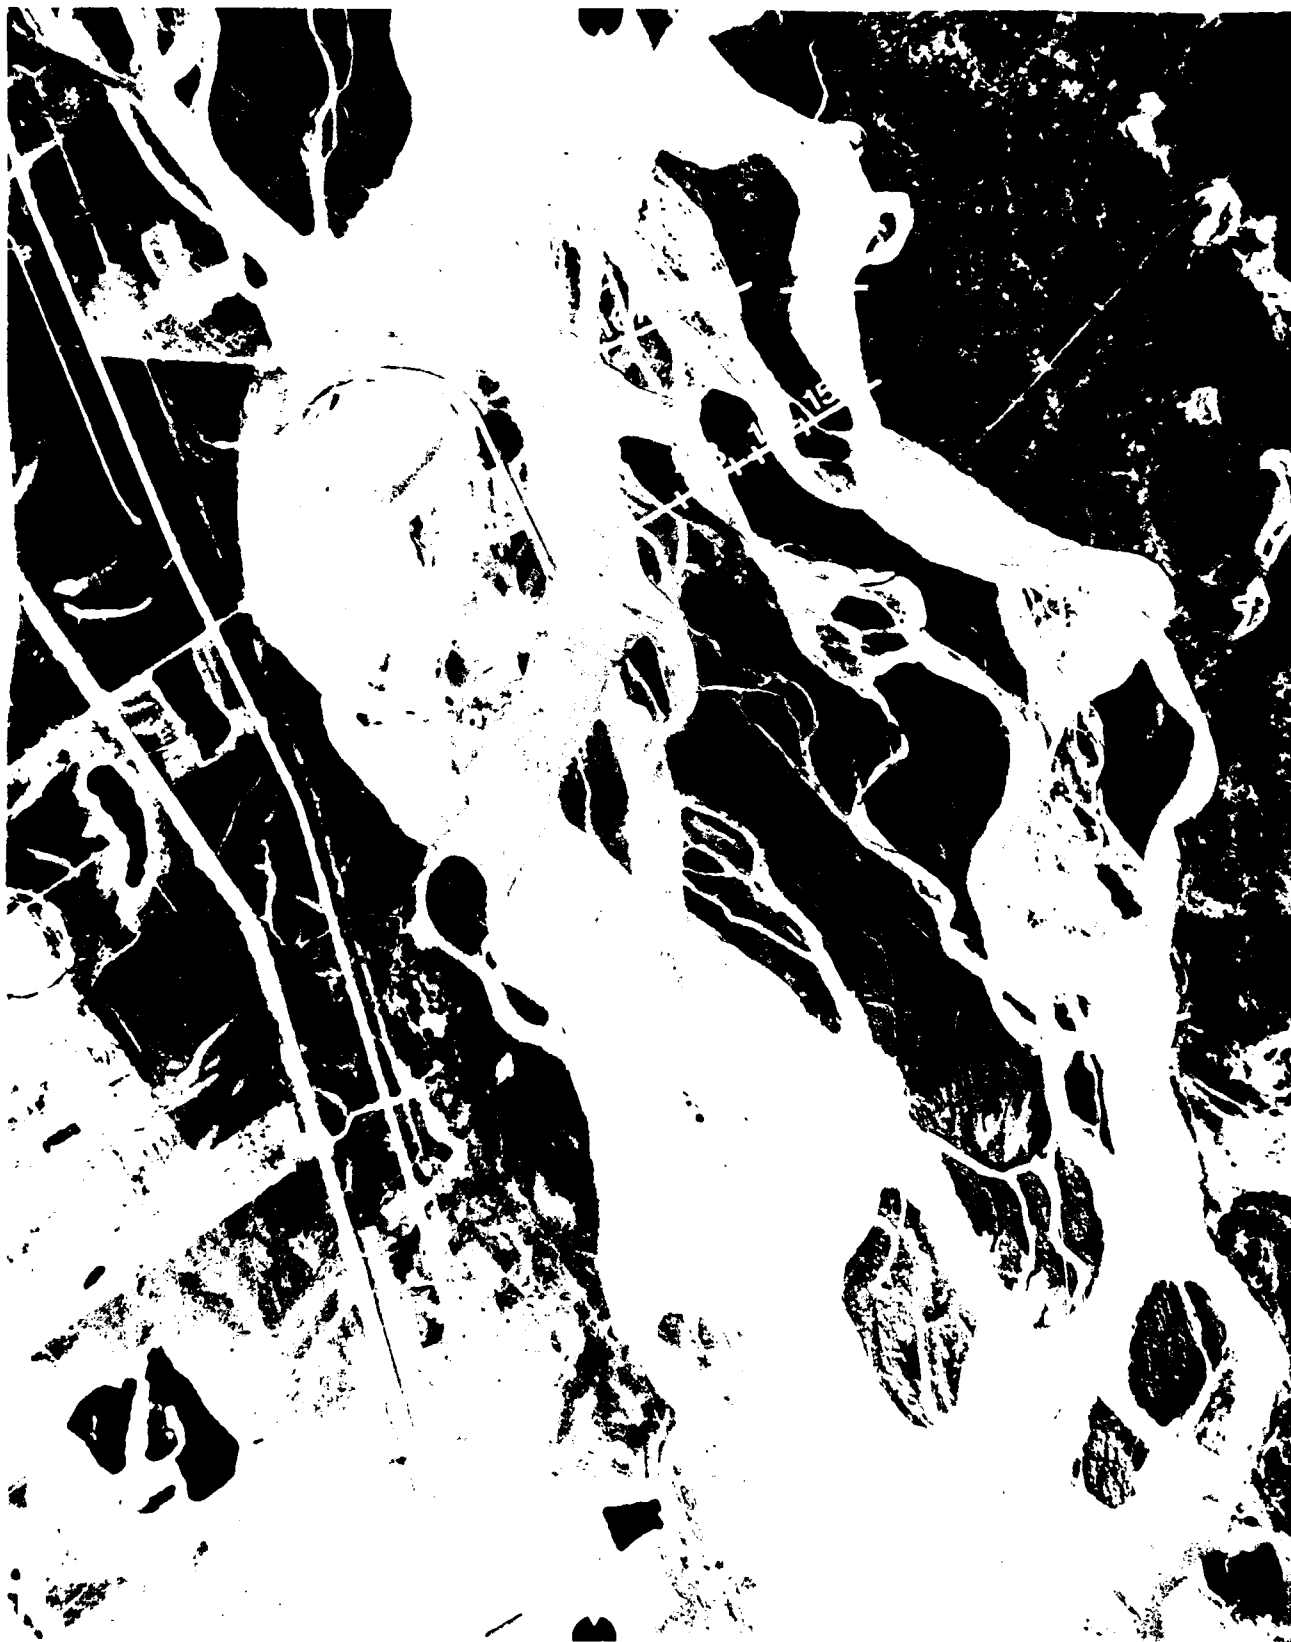
Figure 10. Cross-section locations in the North Pole groin area.

Cross sections were not taken before the North Pole groin was built. After construction, cross-sections at the 16A location (Fig. 10) were taken on 5 October 1977, 17 August 1979 and 3 October 1979. The north reference for the cross-sections was near the groin about 250 ft downstream of the bend in the groin and the cross-sections extended toward the south bank.

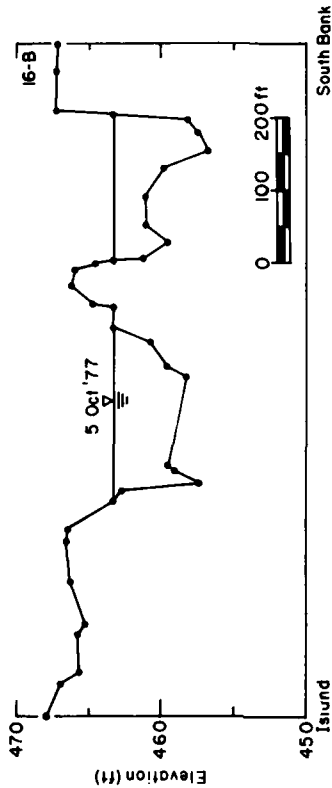
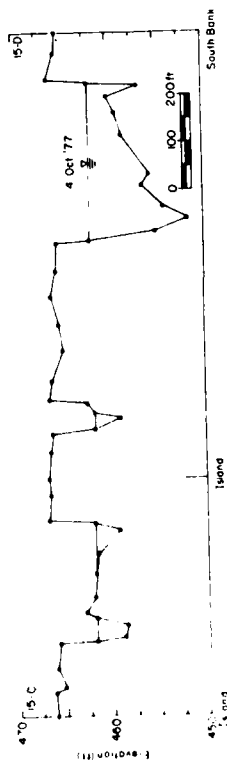
Figure 11. Cross-sections (shown looking upstream) taken on 4 and 5 October 1977 (locations shown on Figure 10).

On 5 October 1977 the deepest part of the channel at 16A (Fig. 11) flowing past the island on the south side of the groin was about 250 ft from the north reference and was at elevation 448 ft. The other cross-sections in Figure 11 were not re-surveyed but are shown to illustrate the general configuration of the channel. By 17 August 1979 (Fig. 12) the deepest part of 16A had migrated to within 150 ft of the reference and was still at elevation 448 ft. The north bank also shifted about 150 ft.

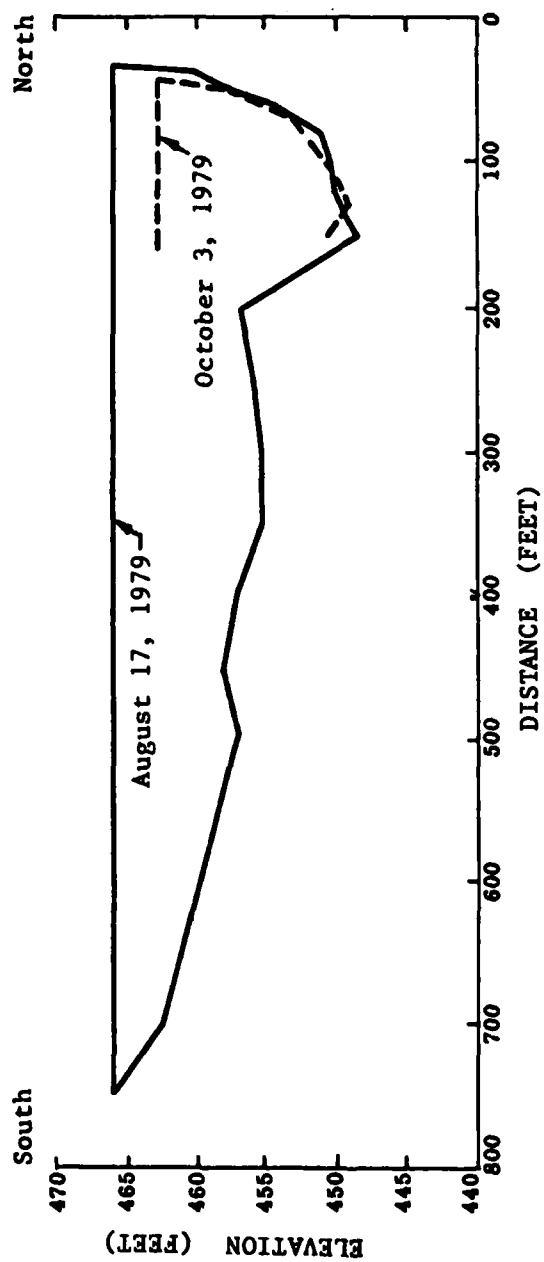
Figure 12. Cross-section 16A shown looking downstream (from Burrows 1980).

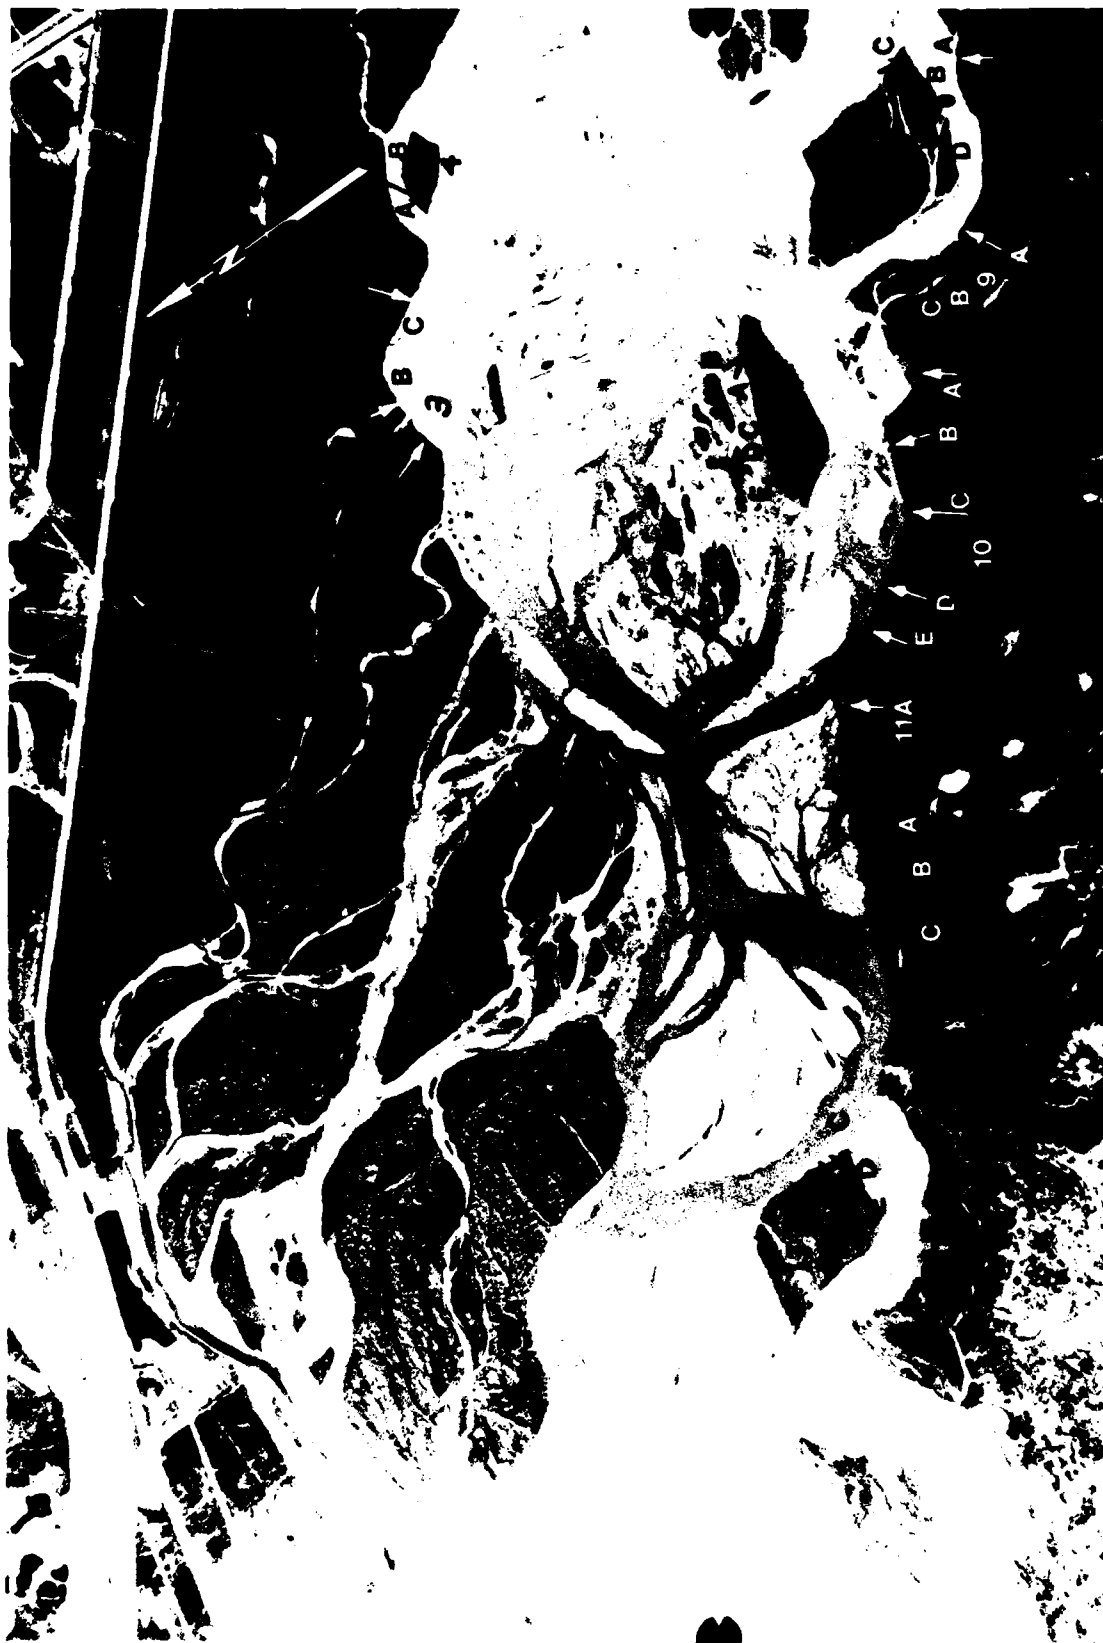
Figure 13. Measuring line locations upstream of the North Pole groin  
(mapping base 17-08, Fig. 1).

Linear bank recession occurred along the outer bends of river meanders at six measuring lines along the north channel (Fig. 13) and along 16 lines along the south channel (Table 4). Most recession occurred along south channel lines and varied from 100 ft at 13D to 540 ft at 10A. Linear recession along the north channel varied from 70 ft at 4A to 460 ft 3B. During this interval the average rate of linear recession per measuring line was highest along the north bank, 40 ft/yr (Fig. 14). The rate along the southern channel was less, 13 ft/yr.

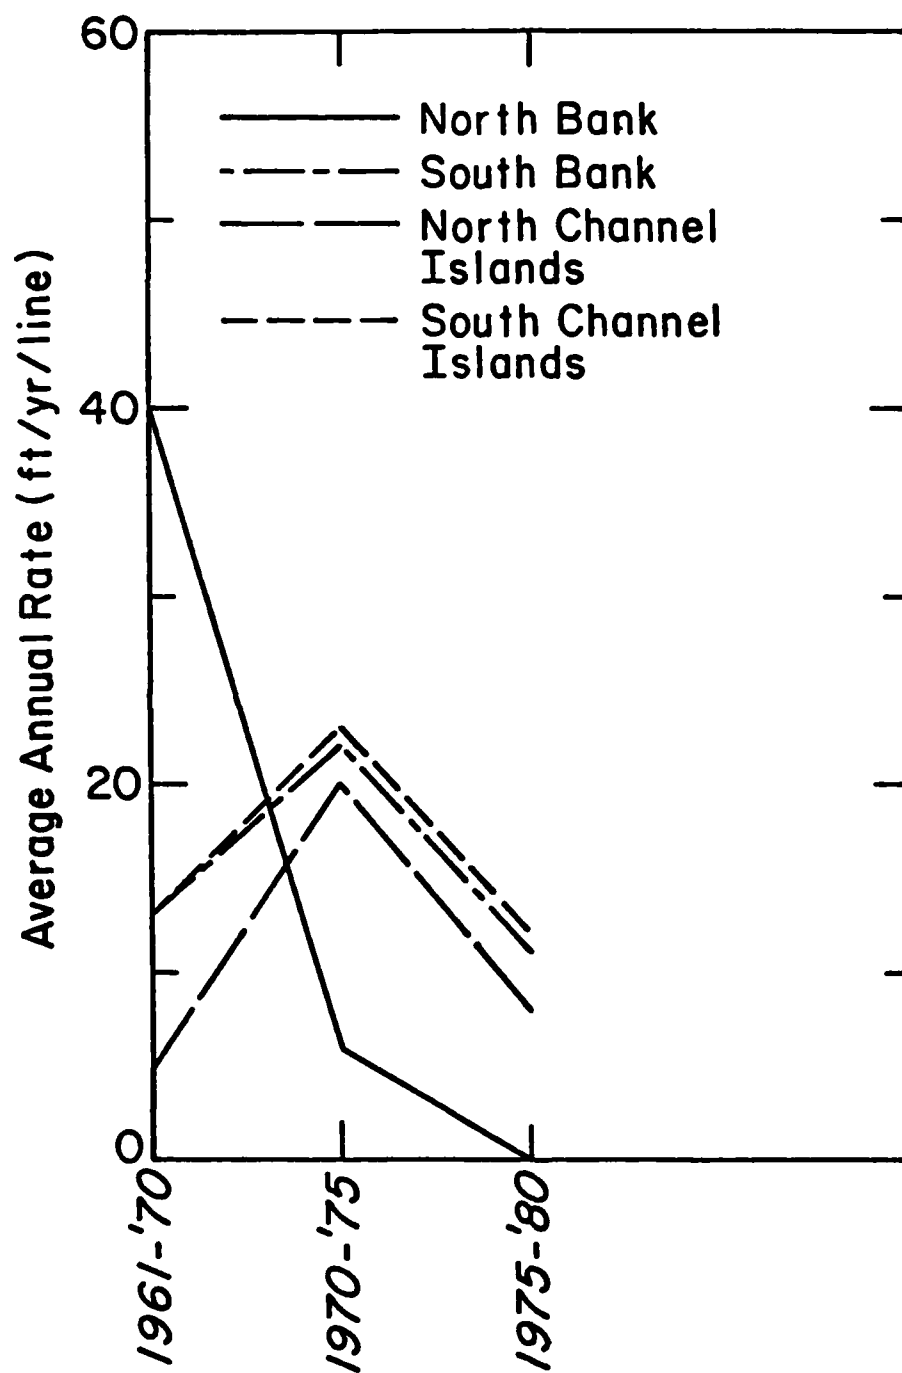
Figure 14. Average linear recession rate per measuring line in the area upstream of the North Pole groin.

Bank recession along the northern channel occurred at most of the measuring lines and varied from 40 to 250 ft (Table 4). Recession along the southern channel was wide spread and varied from 40 to 540 ft. The rates of linear recession were highest along the southern channel as during the previous interval (Fig. 14). Although the meanders in the eastern part of the southern channel migrated from tight bends to more open bends between 1970 and 1975.

The average rate of linear recession along the north bank dropped to 6 ft/yr and increased to 20, 23 and 22 ft/yr along the north and south channel islands and the south bank, respectively (Table 4; Fig. 14). The banks along the southern channel were being eroded more rapidly than those along the northern during this interval (Fig. 14).

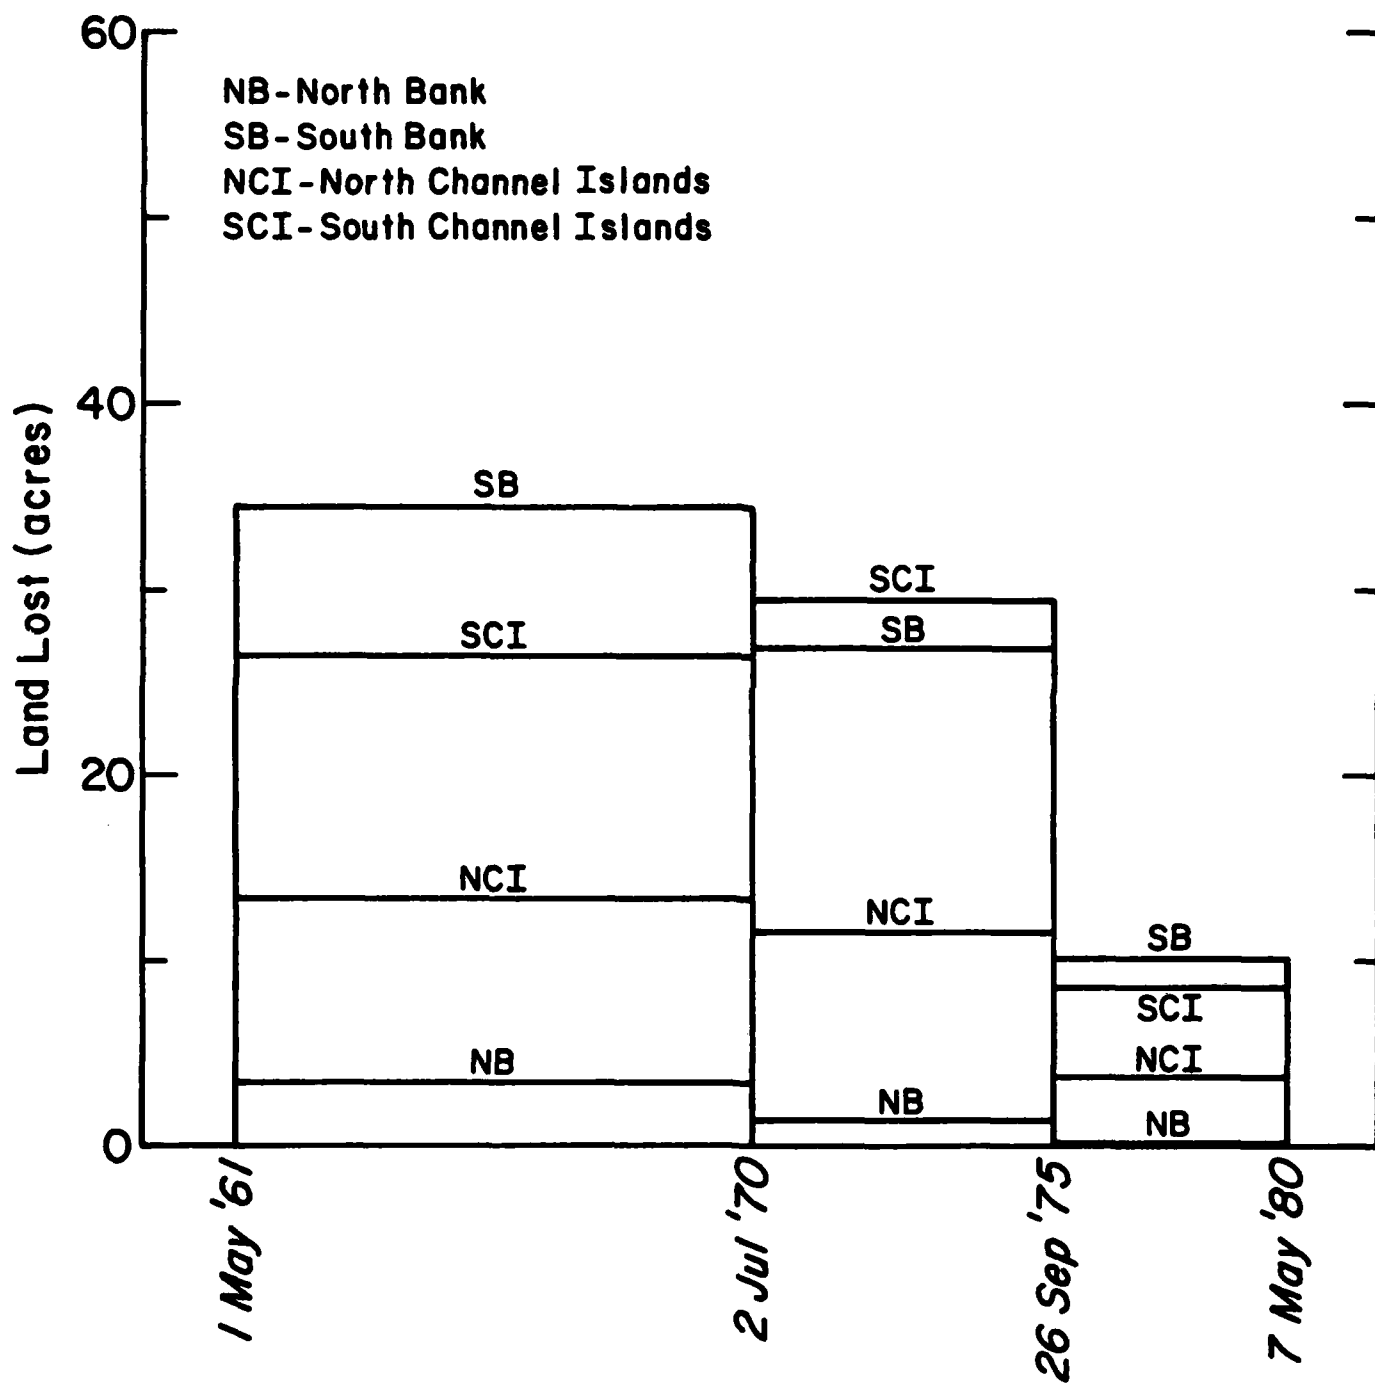
Figure 15. Land lost in the area upstream of the North Pole groin.

The amounts and rates of land lost were highest along the south bank (Table 5; Figs. 15 and 16) and least along the north bank. Bank erosion along the south channel as a whole was greater than that along the north channel. We could not compare these results to those near the groin because the data near the groin are incomplete due to partial photographic coverage.

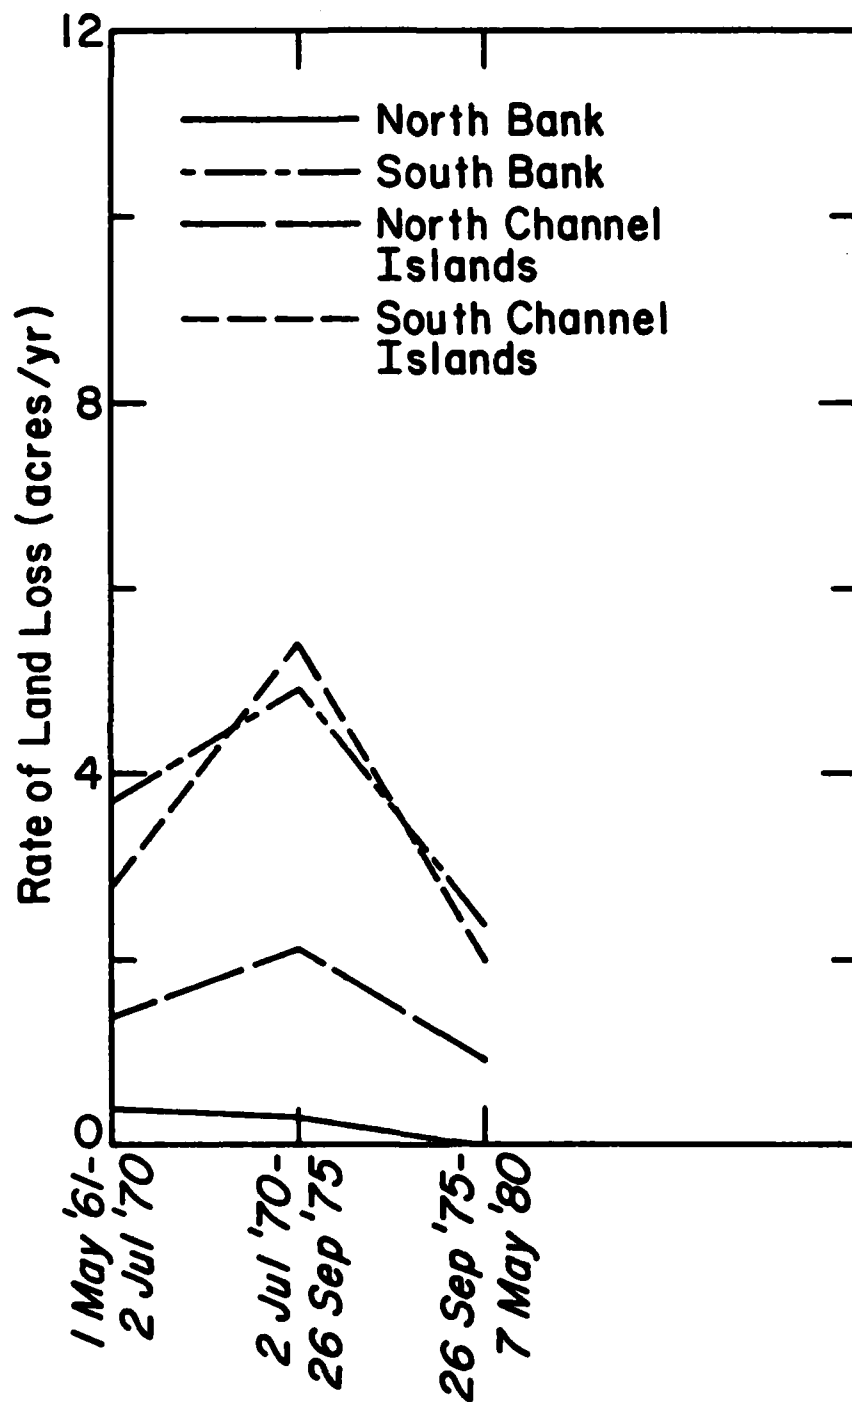
Figure 16. Rate of land lost in the area upstream of the North Pole groin.

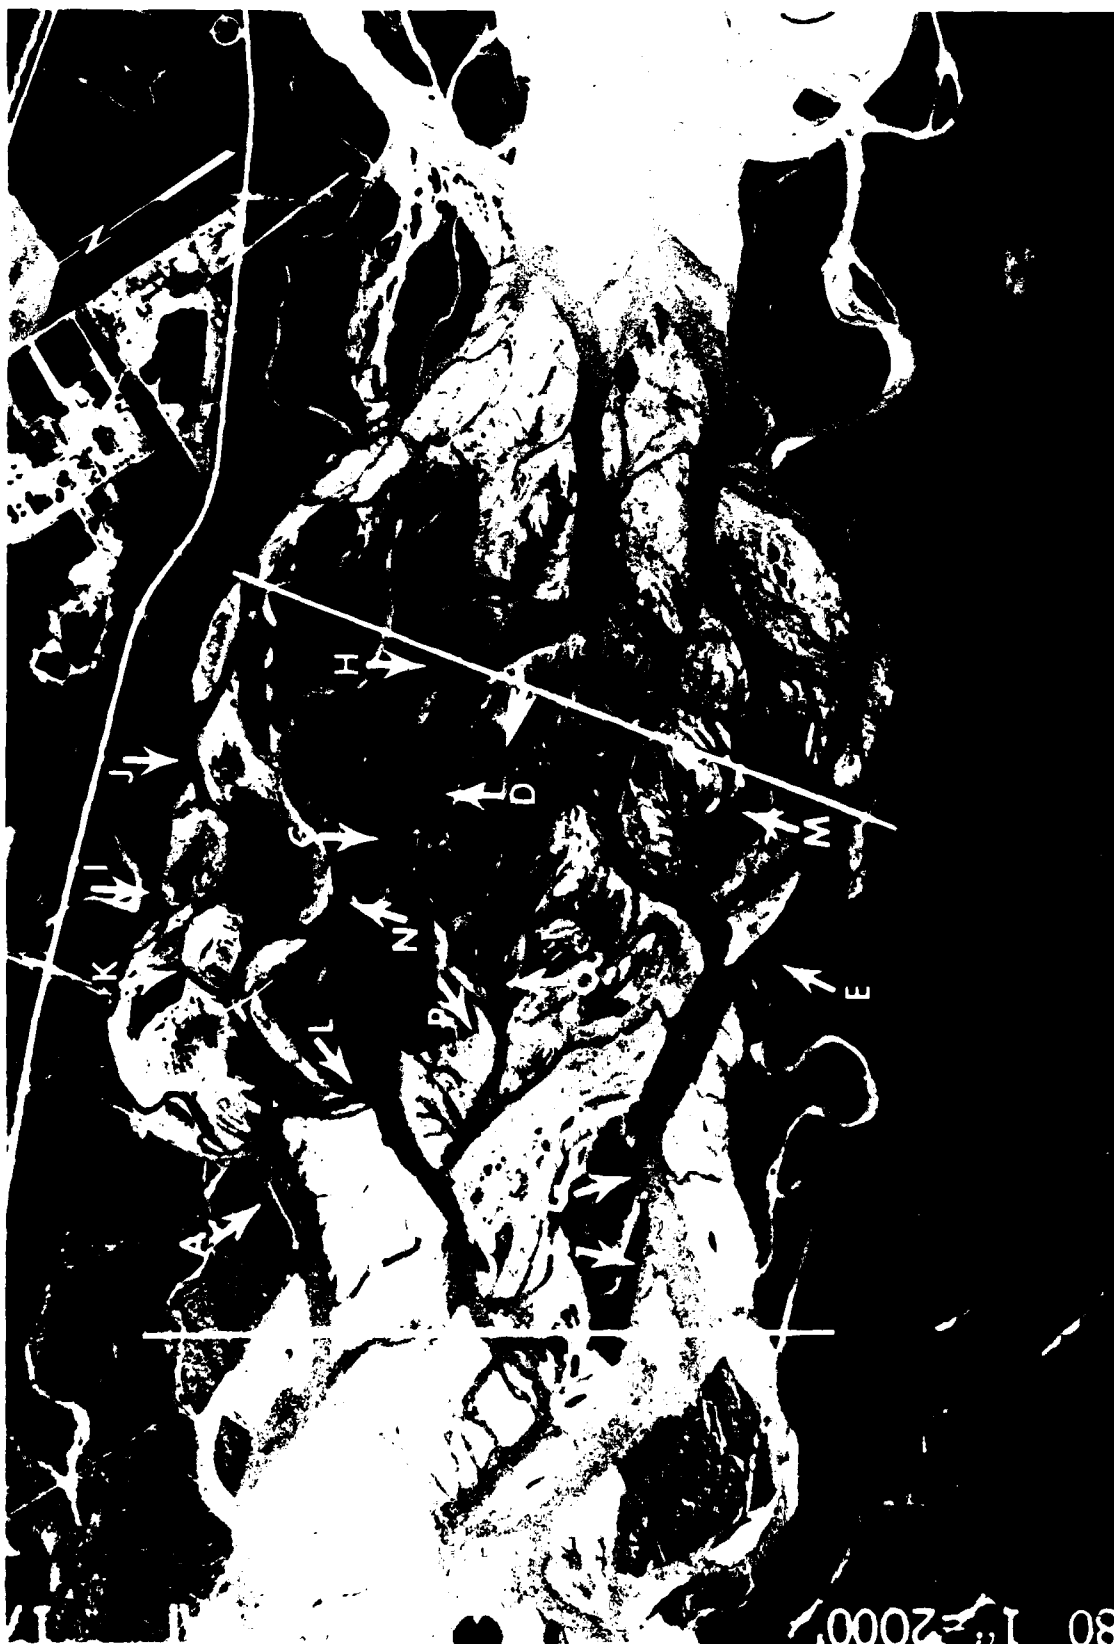
Figure 17. Area 17-06, between 17-08 downstream and 18-18 upstream (see Fig. 1).

Bank recession and channel changes during this interval in the 17-06 area (Fig. 17) were as follows. The main northern flow was in the channels between the north bank and the middle channel adjacent to C and H. The north bank between I and J receded locally but the amounts were minor and occurred along the outside of meanders. Most of the bars and partially vegetated islands in this northern channel were stable and revegetated
